# ESTCP Cost and Performance Report

## Remote Excavation of Heavily Contaminated UXO Sites

December 2007

# **COST & PERFORMANCE REPORT**

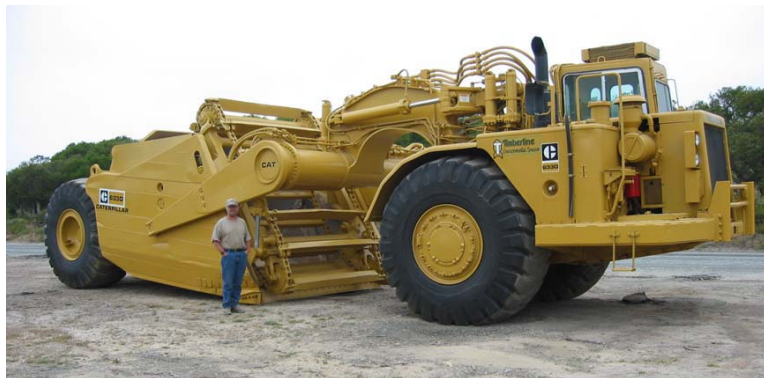
**Figure 1. Range Master Base Carrier.**

Range Master uses current proven and mature technologies that are in commercial use today. The base carrier (see Figure 1) consists of a modified Caterpillar 633D Scraper that is manually operated. The modifications for Phase I included (1) the removal of the scraper's clamshell and its control components, (2) the design, fabrication, and installation of a backing plate to lift site soils to the integrated power screening system, and (3) the purchase, design, and installation of the screening system. The screening system is tilted and provides hydraulic screen shaking. Objects that are too large to pass through the screen network (primary and secondary screens) fall into a wire mesh hopper at the back of the Range Master. The operator controls the hydraulic dumping of the screened hopper contents for examination by UXO personnel. Designed specifically to handle UXO up to 105-mm projectiles, the Range Master is physically capable of handling much larger ordnance (e.g., 500-lb bombs) up to the limits of the lifting paddles. Sifted soil drops through the screen unit back onto the site directly under the Range Master. When the screened item hopper is full, the operator hydraulically dumps its contents directly below the Range Master for inspection. OB/OD areas, old or current target impact areas, strafing ranges, 40-mm ranges, and small arms ranges with very high concentrations of surface and subsurface metallic signatures that would reduce the effectiveness of DGM are all areas where Range Master could be applied.

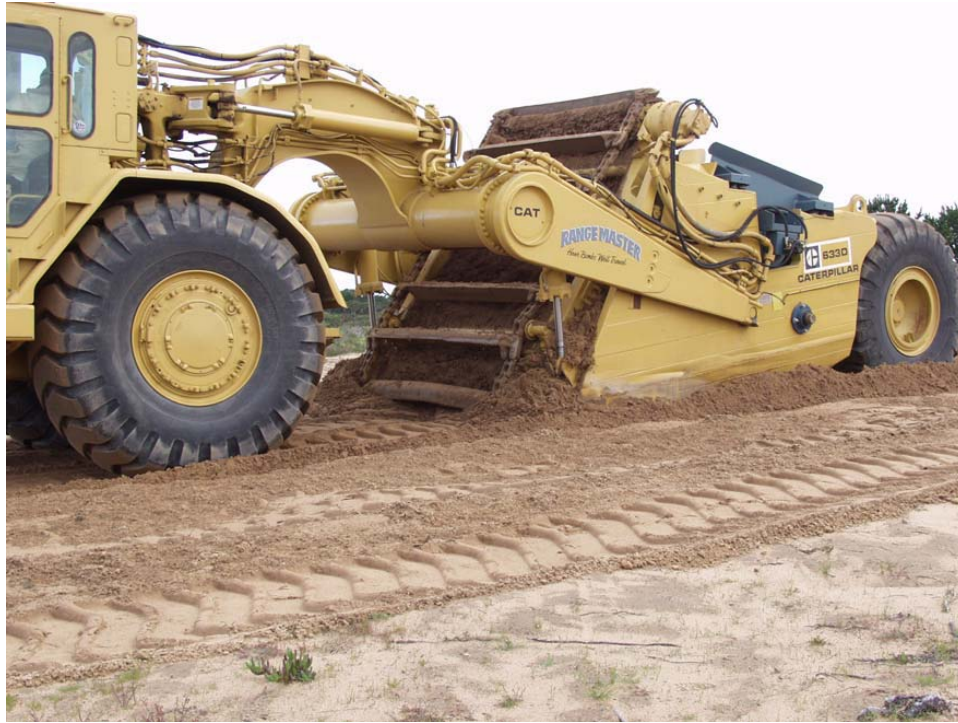
**Figure 2. Range Master at Phase I Demonstration (Manual Operation).**

During Stage 1, the base carrier was modified for the integrated screening unit. Under Stage 2, the screening unit was purchased, modified to fit in the Range Master, and installed. The hydraulic controls were modified to power the screens and to open and close the hopper. Stage 2 ended with the Phase I demonstration (Figure 2).

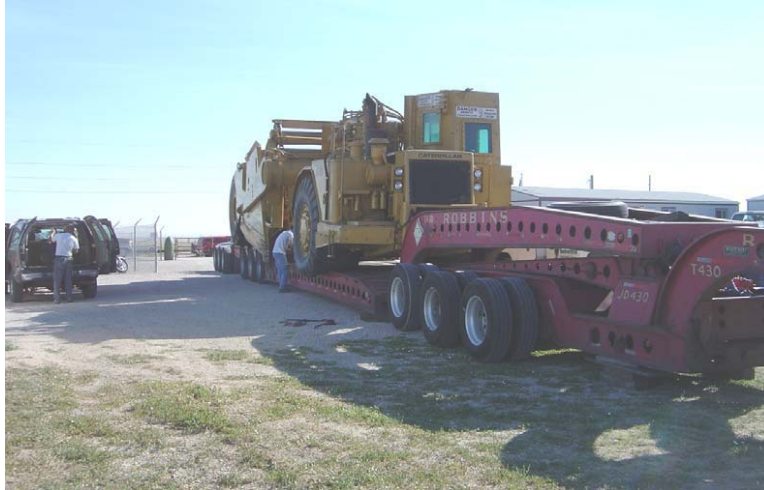
**Figure 4. Range Master Transported on Nine-Axle Trailer.**

Mobilization/demobilization, contiguous excavation area, soil and terrain conditions, and on-site maintenance are considered the major cost drivers. The Range Master's weight requires a heavy-duty 9-axle trailer, with special permits and escorts required, to move it from place to place. The best estimate for Range Master transportation costs is \$18/mile. Maintenance costs need to be considered in terms of time and material costs and availability. Most parts are available off-the-shelf, either new or used, worldwide. Maintenance of these items will be minimal. However, should the Range Master require depot-level maintenance, either bringing the depot on site or returning the Range Master to the depot will add significant cost and time.

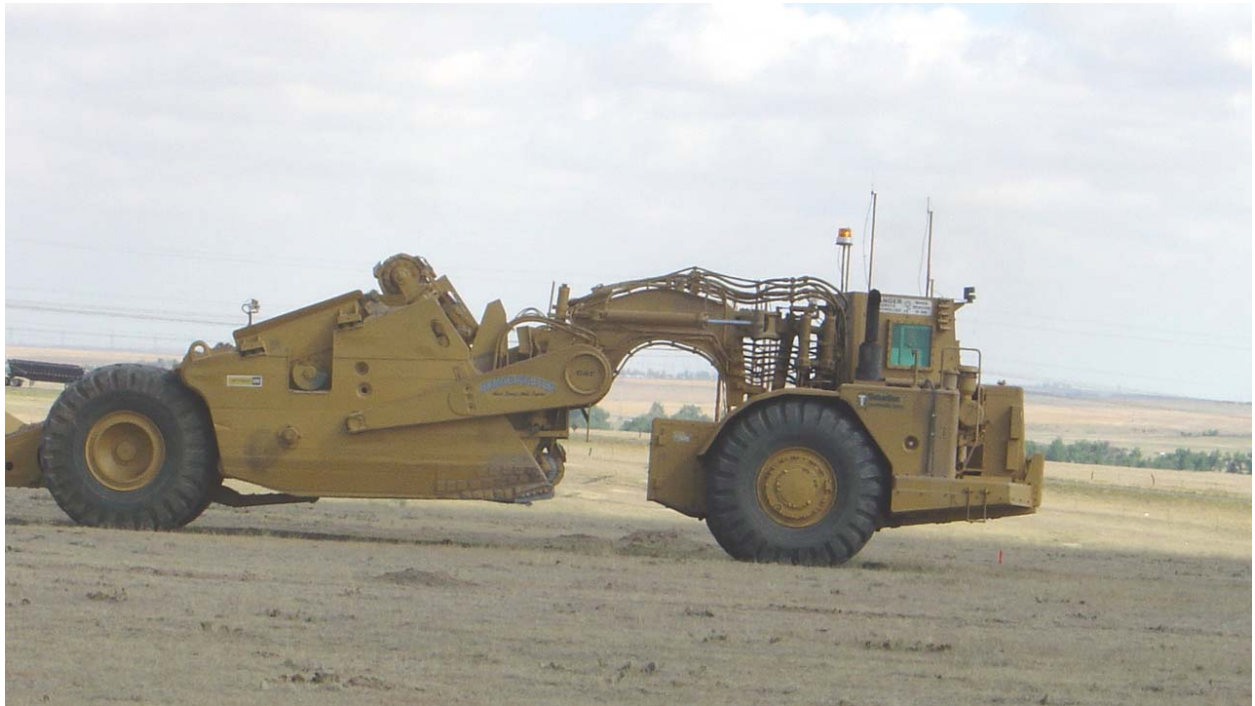
**Figure 5. Range Master at Phase II Demonstration (Armored and Remote Controlled).**

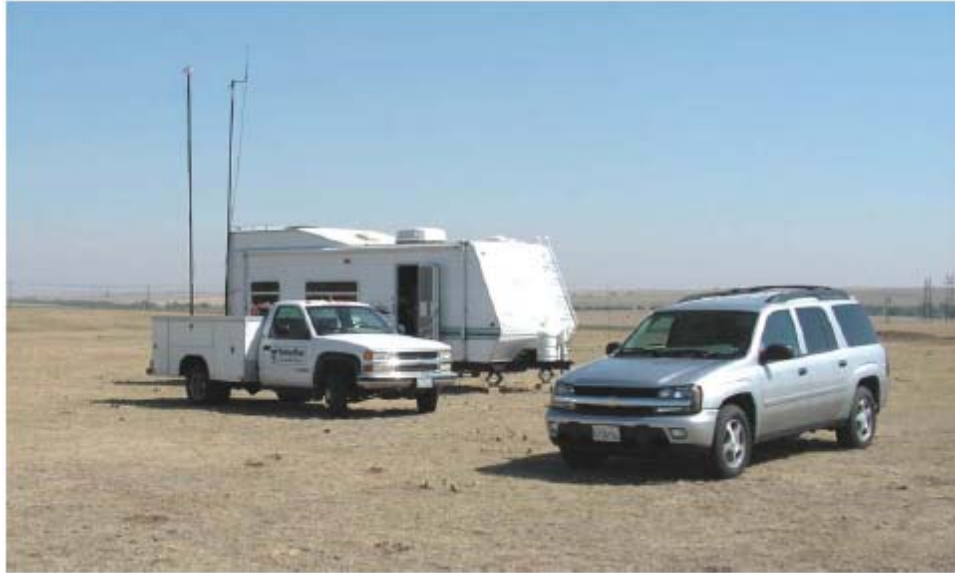
**Figure 6. Phase II Remote Control Platform and Tow/Support Vehicle.**

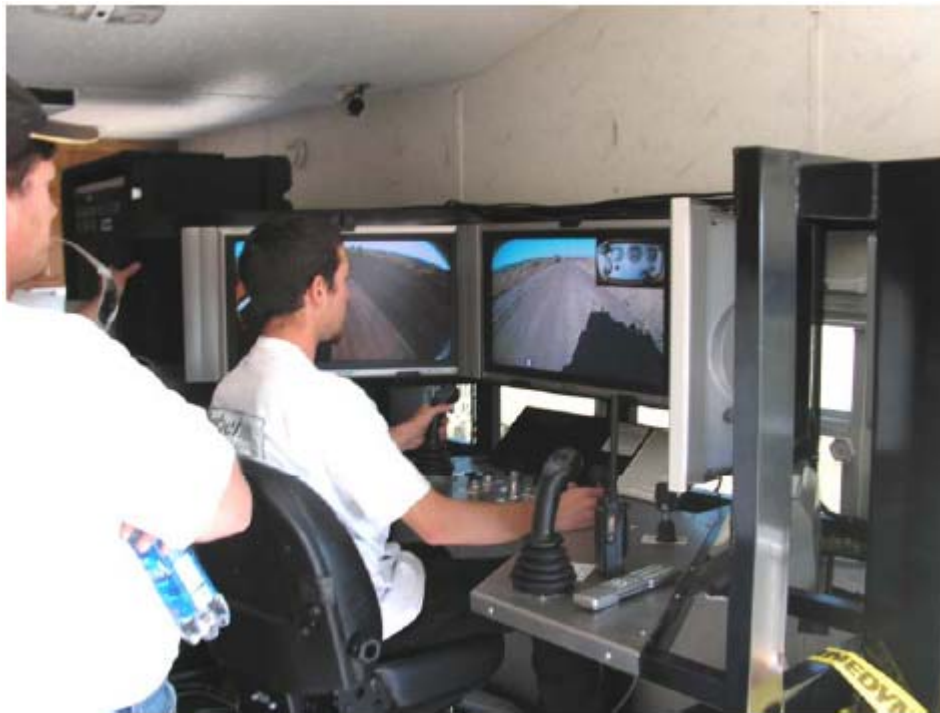
**Figure 7. Remote Control Platform Video Monitors and Control Station.**

All video cameras were adjusted to provide optimum feedback. The split screen monitors all worked well. The air nozzles mounted to each camera kept the lenses clean even under very dusty conditions.

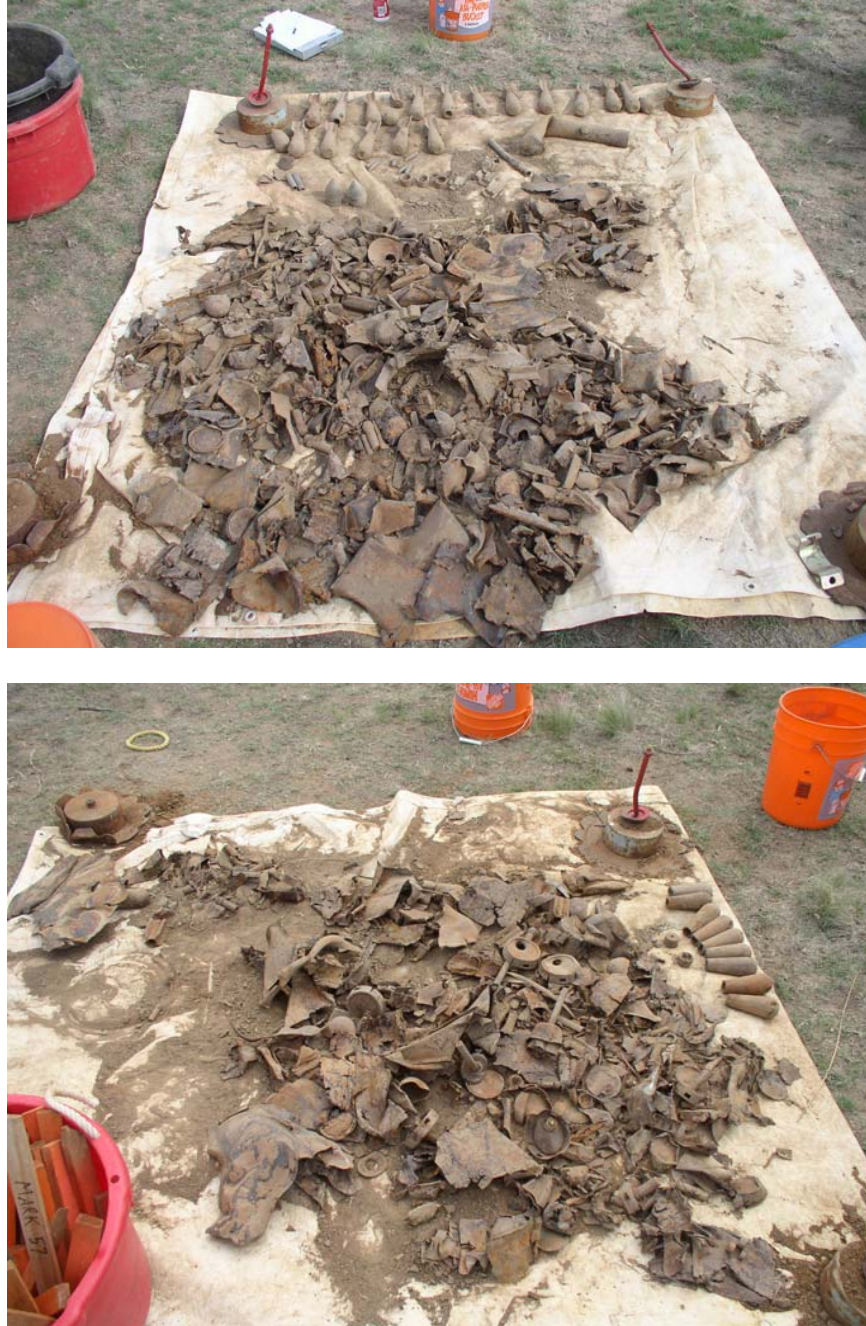
**Figure 8. Photographs of Items Excavated by Range Master from FLBGR BT#2.**

<b>Item Excavated</b>	<b>From Dump Piles</b>		<b>From Grids</b>	
Mk 23 bomb	35	each	15	each
Booster cup	3	each		
Booster (M152 fuze)	2	each		
HE bomb frag	1	each		
HE brag	3	each		
OE scrap	2,059	each		
2.25-inch rocket	1	each		
Small arms	11	each		
Non Ordnance & Explosive (OE) scrap	3	each		
<b>Subtotals</b>	2,118	each	15	each
Estimated weight of items excavated	443	lb	65	lb
